Manhole Inspection Summary

Manhole # S17II_033MH

Insp Date: **6/8/07 10:04 AM**

Location Address: **1651 RUXTON-BENTALOU**

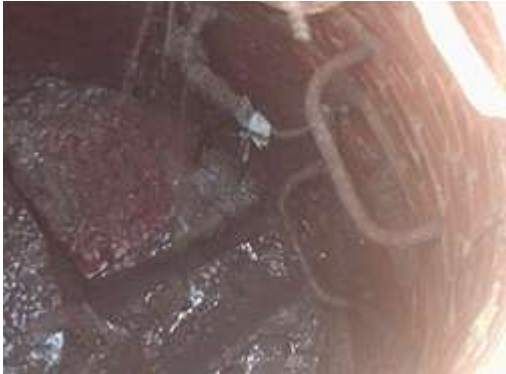
Defect 4

☒ **Evidence Of Surcharge** Depth: **4** (ft.) ☐ Active Surcharge Present

SURCHARGE EVIDENCE ON STEPS

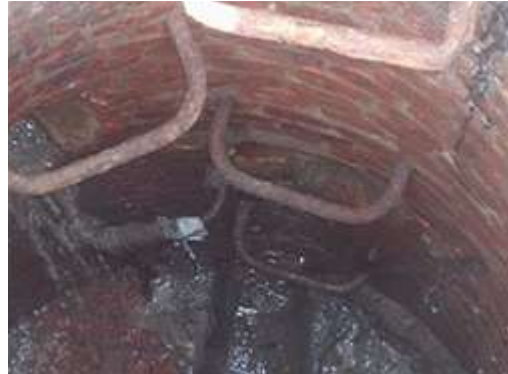
Defect 2

Count: **5** Missing: **0** ☒ **Corroded**

CORRODED STEPS

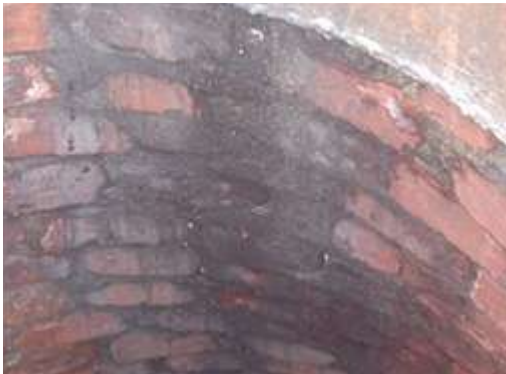
Defect 3

Infiltration: ☐ None ☒ **Joint** ☐ Cracks ☐ Mortar ☐ Roots ☐ Wall

INFILTRATION OF CHIMNEY

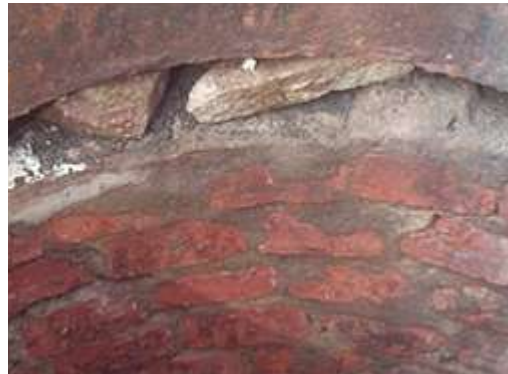
Defect 1

Condition: ☐ Sound ☐ Cracked ☐ Root Intrusion ☐ Loose Brick ☒ **Deteriorated**

DETERIORATION OF CHIMNEY

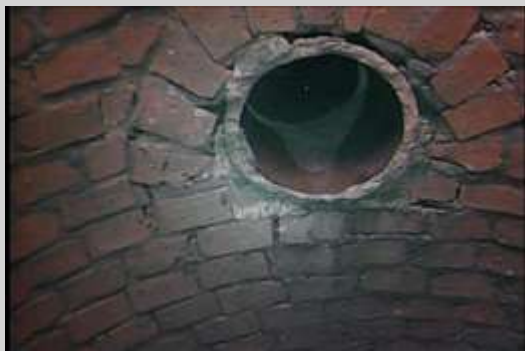
3 O'Clock Inflow

INFILTRATION OF CHIMNEY

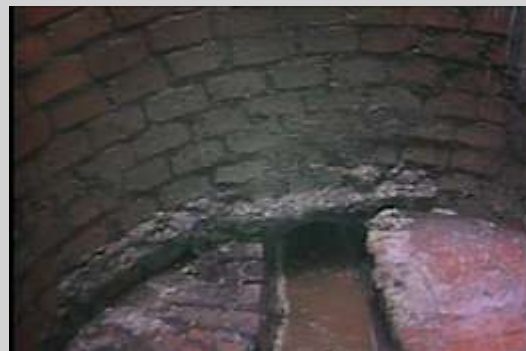
Drop In @ 3 O'Clock

INFILTRATION OF CHIMNEY

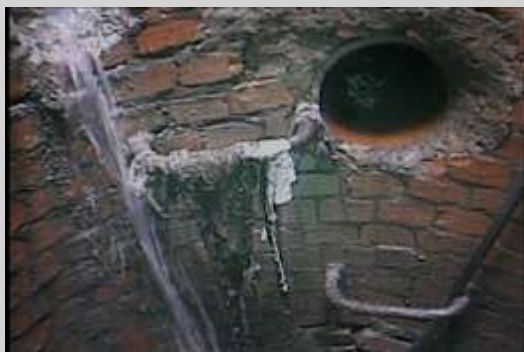
6 O'Clock Inflow

INFILTRATION OF CHIMNEY

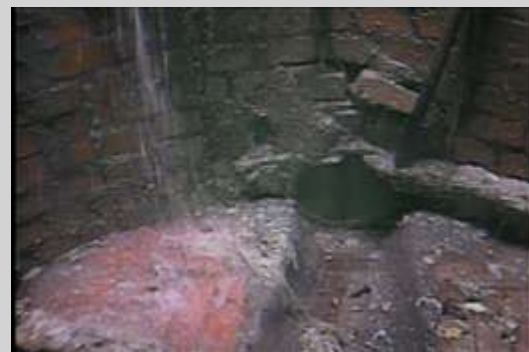
Drop In @ 6 O'Clock

INFILTRATION OF CHIMNEY
